Restoring Delaware Historical Society's Hidden Gem

EDiS Company worked on behalf of the Delaware Historical Society (DHS) to complete repairs they needed done on The Annex building directly adjacent to their research library and archives at 505 North Market Street. When it came time to repair parts of the library itself, the DHS took the opportunity to have it restored by EDiS as well. Cement covering the upper portion of the facade had fallen onto the unoccupied street below, and DHS was concerned that the remainder might eventually fall too. They called on EDiS Company and **Senior Superintendent and Manager of the Interiors/Service Division Joe Pedicone** to safely remove the cement covering from the three remaining medallions.

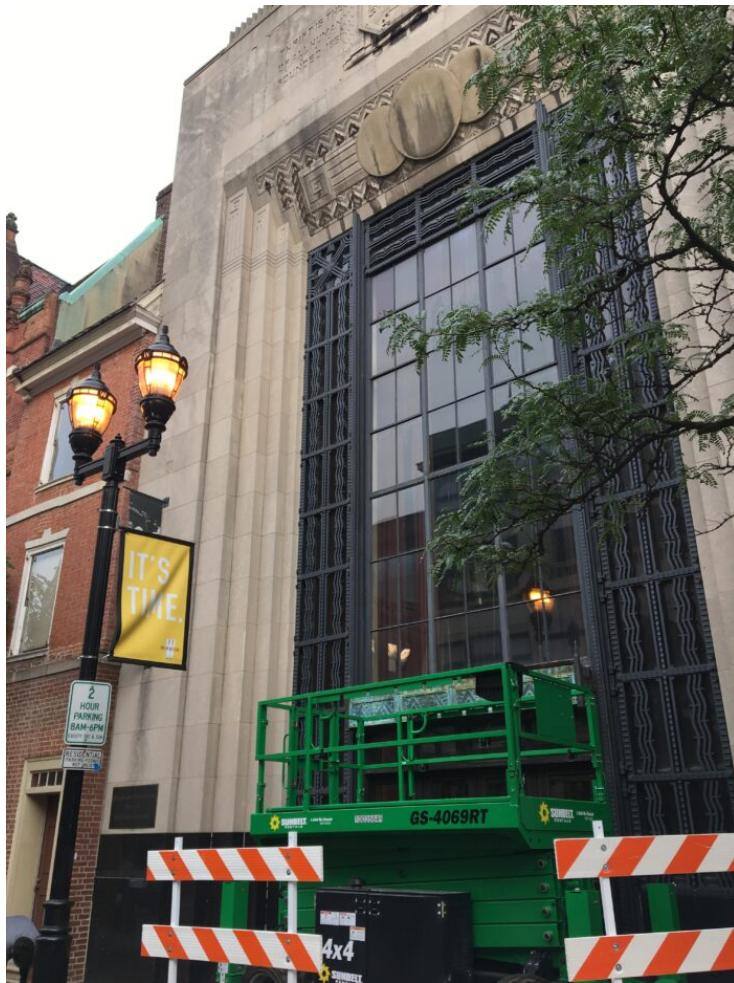
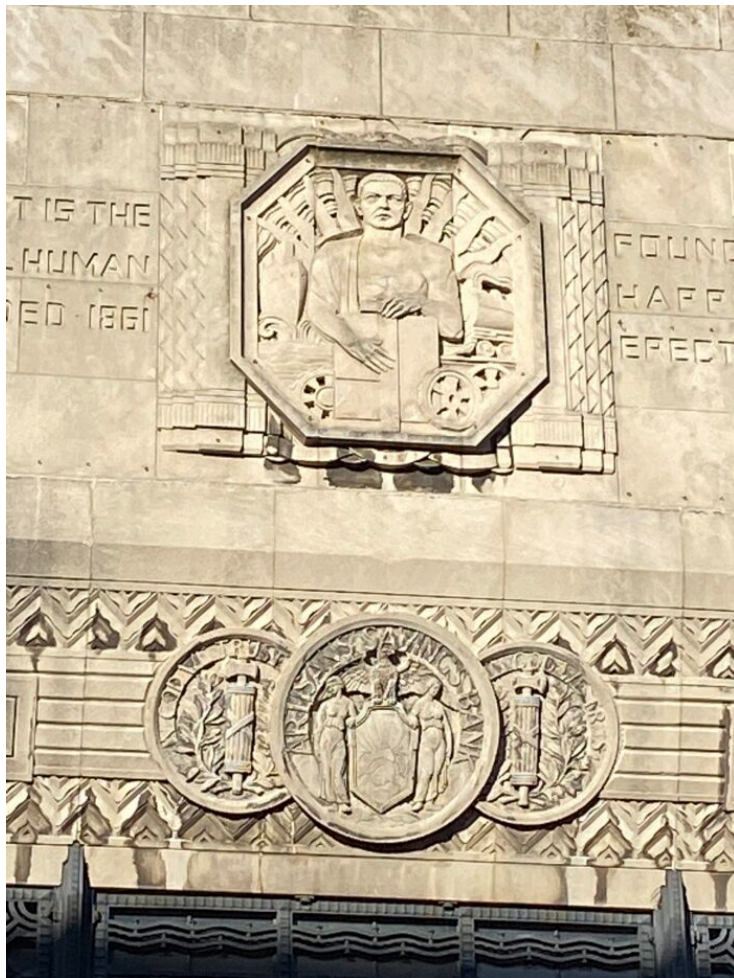
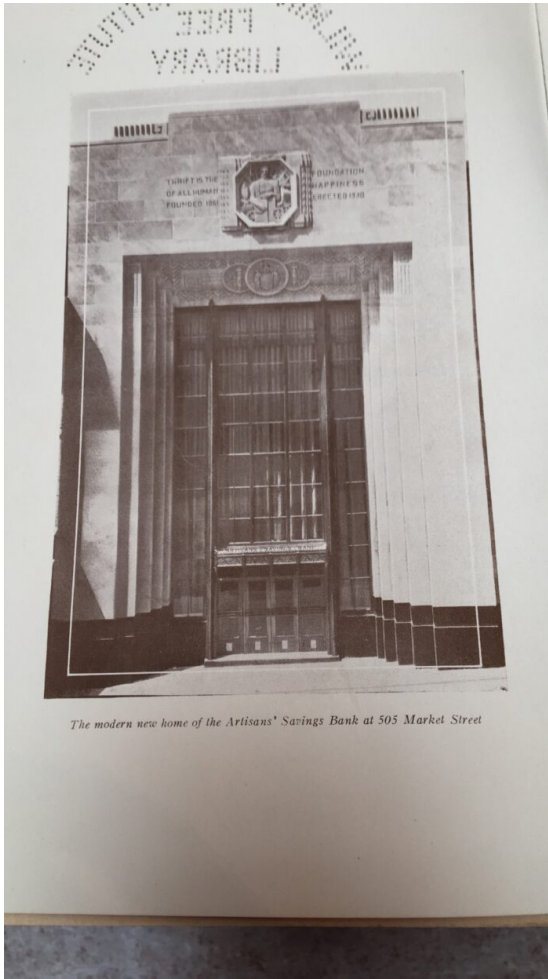
The two materials, limestone and cement, hadn't bonded properly in 1972 when they were filled because of their difference in density, causing them to expand and contract at different rates. If the removal job had been done only 20 years ago, the medallions could have been destroyed due to the limestone not having enough time to release from the cement. If noticed too late or removed too roughly, the carvings would have been lost when the cement was removed from their surface.

DHS medallions covered left, restored middle, and original 1931 facade right

Joe and his team barricaded the street below for safety before beginning a two-day renovation. The team used chippers and saws to carefully remove the remaining cement before power-washing and brushing the limestone. With the polishing and refinishing of the limestone medallions completed, the building was restored to its former glory, just as it had been 90 years ago.
